Manhole Inspection Summary

Manhole # S35Q__062MH

Location Address: **1101 s hanover st**

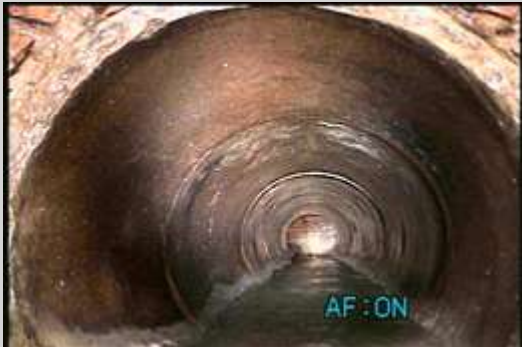
12 O'Clock Outflow

21 in. Circular Gravity Sewer
Pipe Out @ 12 O'Clock

Pipe Material: **Clay** ☐ Pipe Lined

Invert Depth: **9.66** (ft.) Flow Characteristics: **Fast**

Deposits: ☒ None ☐ Mud ☐ Sludge ☐ Debris ☐ Grease

Infiltration: **None** Pipe Seal Cond: **Unknown**

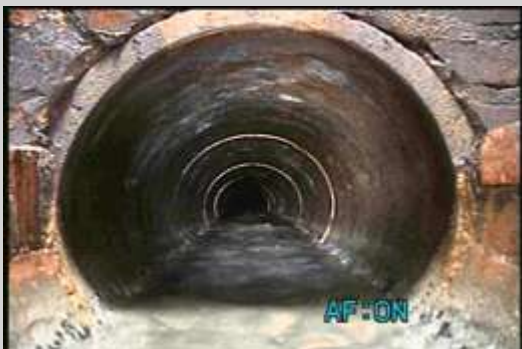
4 O'Clock Inflow

15 in. Circular Gravity Sewer
Pipe In @ 4 O'Clock

Pipe Material: **Clay** ☐ Pipe Lined

Invert Depth: **9.41** (ft.) Flow Characteristics: **Fast**

Deposits: ☒ None ☐ Mud ☐ Sludge ☐ Debris ☐ Grease

Infiltration: **None** Pipe Seal Cond: **Unknown**

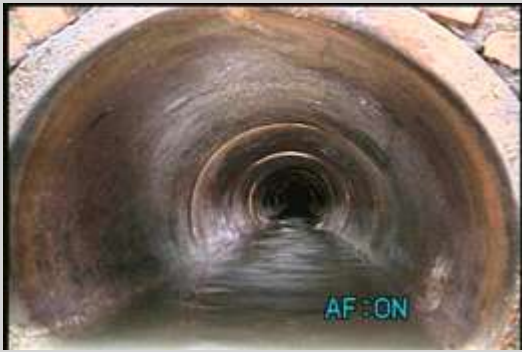
6 O'Clock Inflow

18 in. Circular Gravity Sewer

Pipe In @ 6 O'Clock

Pipe Material: **Clay** ☐ Pipe Lined

Invert Depth: **9.50** (ft.) Flow Characteristics: **Fast**

Deposits: ☒ None ☐ Mud ☐ Sludge ☐ Debris ☐ Grease

Infiltration: **None** Pipe Seal Cond: **Unknown**

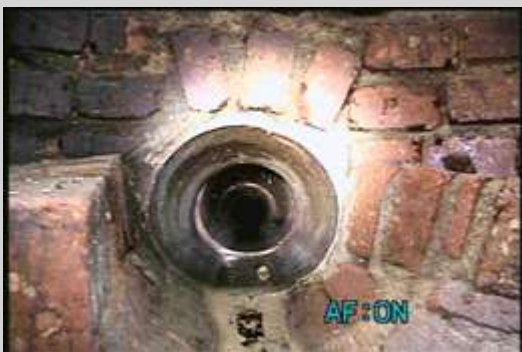
9 O'Clock Inflow

8 in. Circular Gravity Sewer

Pipe In @ 9 O'Clock

Pipe Material: **Clay** ☐ Pipe Lined

Infiltration: **None** Pipe Seal Cond: **Unknown**
